OPERATING EXPERIENCE WEEKLY SUMMARY

Office of Nuclear and Facility Safety

August 28 - September 3, 1998

Summary 98-35

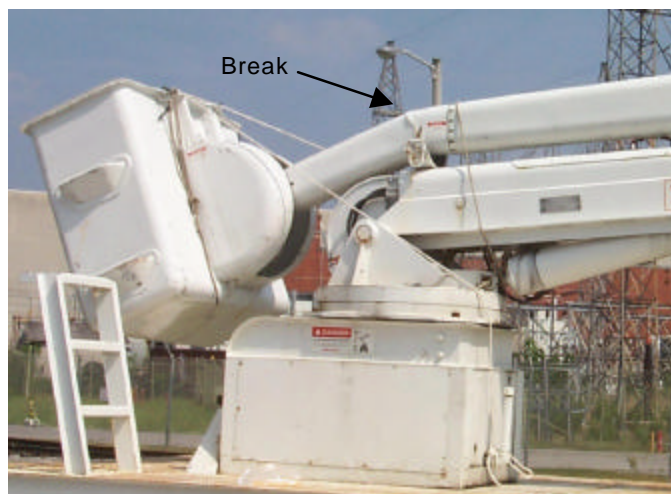
Figure 1-1. Bucket Truck Boom

On August 19, 1998, at Oak Ridge Environmental Restoration Operations, a fiberglass boom on a bucket truck broke and dropped approximately 3 feet as two linemen performed cable-end preparations about 25 feet above the ground. A steel cable that runs through the hollow boom and attaches to the bucket and the internal metal reinforcements arrested the fall. The linemen lowered the boom/bucket and safely exited the bucket. Both linemen were secured with safety harnesses and lanyards and were not injured. This event could have resulted in serious injuries or fatalities. (ORPS Report ORO--BNFL-K32-1998-0003)

Investigators believe the fiberglass boom, manufactured by Hi-Ranger, was less than a year old and had been inspected and tested about 1 month earlier. They determined that the boom broke approximately 4 feet from the bucket and that the bucket had been stationary for 5 to 10 minutes before the boom broke and fell. They also determined that the rated capacity of the boom/bucket was not exceeded. Investigators determined that the steel cable functions to keep the bucket level as the boom moves vertically (see Figure 1-1). Investigators also determined that the boom broke at the point where it latches to a cradle used to limit its movement when the truck is moving. Facility managers contacted Hi-Ranger, and the manufacturer is investigating the cause of the break. The subcontractor and facility managers are also investigating the failure. OEAF engineers will follow the investigation and provide information as it becomes available.

These events underscore the importance of following guidelines for the use of personnel lifting equipment. They also underscore the need for adequate fall protection safety equipment when working from an elevated position. Facility managers should review the following guidance and should ensure that it is applied when work is performed from elevated positions.
